Manhole Inspection Summary

Manhole # S43G__029MH

Insp Date: **6/2/08 9:57 AM**

Location Address: **1654 e pratt st**

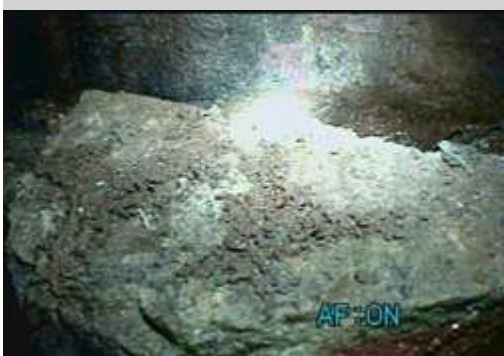
Defect 4

Condition: ☐ Sound ☐ Cracked ☐ Root Intrusion ☐ Deteriorated ☐ Leaks ☒ **Debris**

bench debris

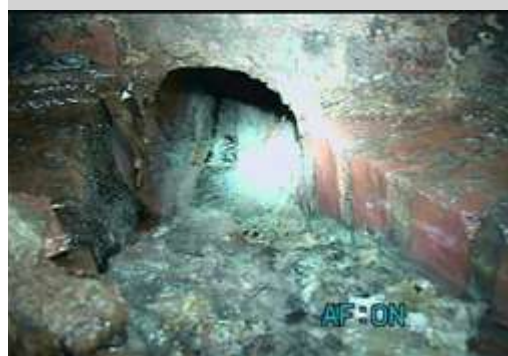
Defect 3

Condition: ☐ Sound ☐ Cracked ☐ Root Intrusion ☐ Deteriorated ☐ Leaks ☒ **Debris**

channel debris

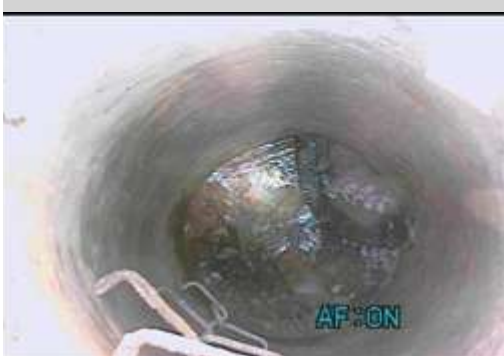
Defect 2

Steps Count: **5** Missing: **0** ☒ **Corroded**

corroded steps

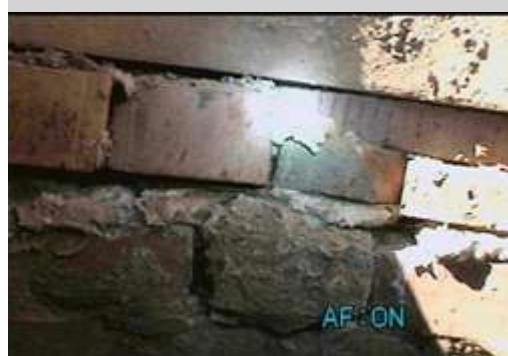
Defect 1

loose brick

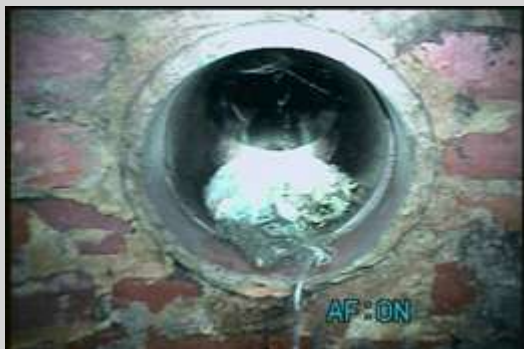
9 O'Clock Inflow

Drop Condition: Partly Clogged
